Dermatac™
Drape

3M™ Dermatac™ Drape with 3M™ V.A.C.® Therapy case studies

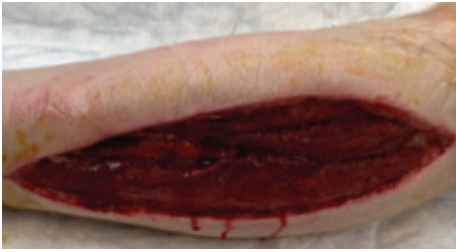
Figure 1. Left lateral calf at presentation (20cm x 12cm x 0.1cm).

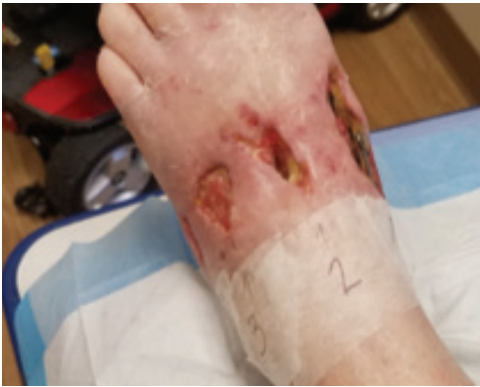
Figure 1. Dehiscent wounds after debridement, 1 week of 3M™ Veraflo™ Therapy with standard drape, and 1 week of 3M™ V.A.C.® Therapy with 3M™ Dermatac Drape.
