Veraflo™
Therapy

3M™ Veraflo™ Therapy

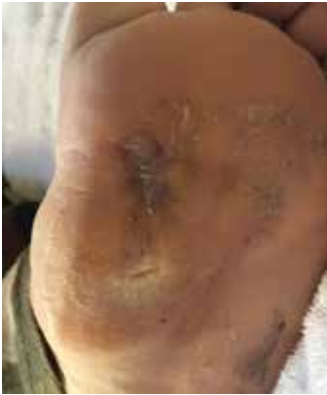
Figure 1. Diabetic foot abscess upon admission.

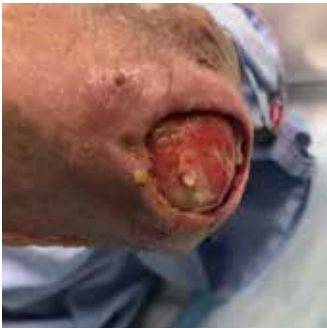
Figure 1. Wound at presentation.

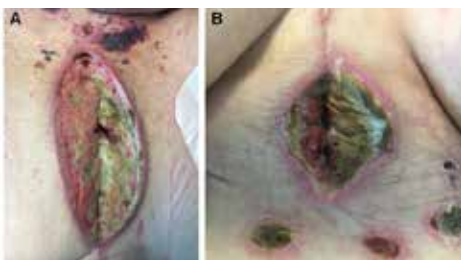
Figure 1. Wounds at presentation. Sternal (A) and midline (B) wounds are shown.

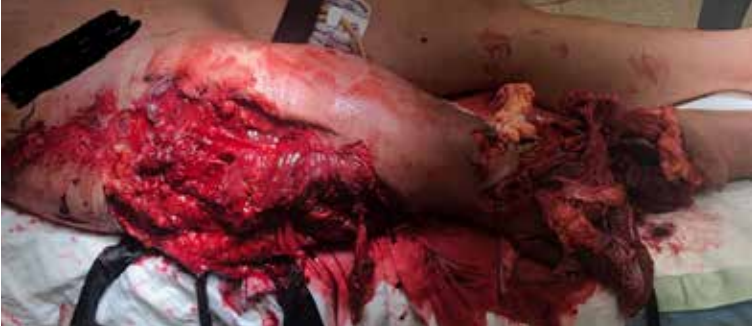
Figure 1. Extensively injured right leg at initial presentation.

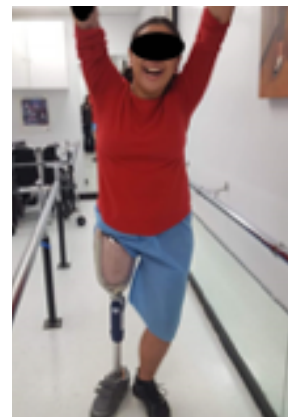
Figure 8. Patient 167 days after initial injury, taking first steps on a new prosthesis.
