Prevena™
Incision Therapy

Use of 3M™ Prevena™ Therapy after spinal fusion complicated by metastatic cancer

Kyle Mueller, MD; Department of Neurosurgery, Brown University & Rhode Island Hospital, Providence, RI

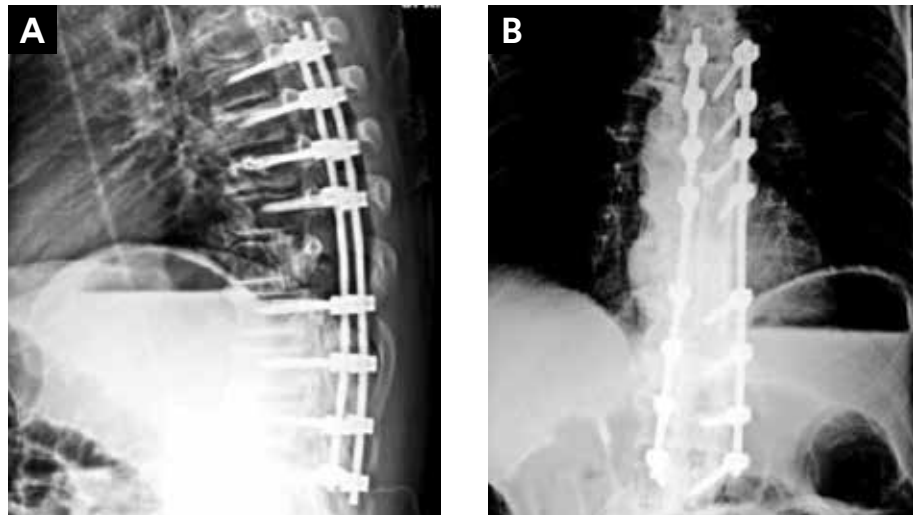
Figure 1. X-rays showing T6-L2 instrumented fusion from the left lateral (A) and dorsal (B) perspectives.

The patient was admitted for a multi-level T6-L2 posterior instrumented fusion with a T10 corpectomy with cement reconstruction (**Figures 1 and 2**).

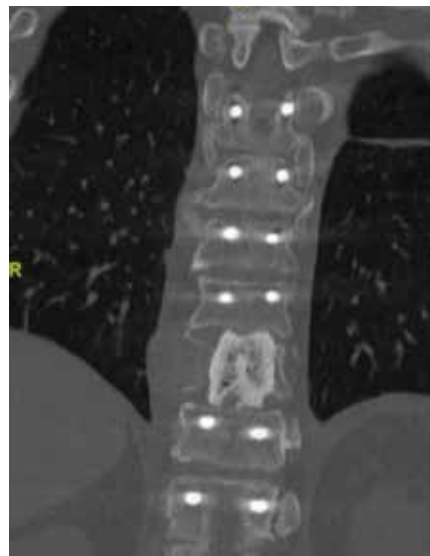
Figure 2. CT scan showing instrumented fusion with T10 corpectomy with cement reconstruction.

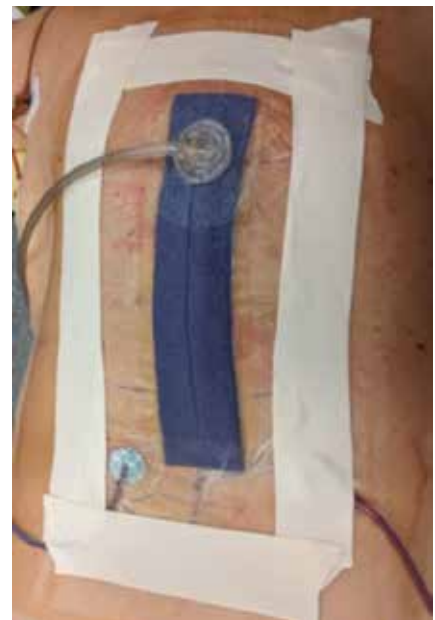
Figure 3. Placement of 3M™ Prevena™ Customizable Dressing and application of negative pressure.

After closure of the spinal incision, a 3M™ Prevena™ Plus Customizable Dressing was applied with -125 mmHg negative pressure (**Figure 3**) with the 3M™ Prevena™ Plus 125 Therapy Unit. The drape border was lined with foam tape to ensure that a seal is maintained while the patient recovers in the supine position postoperatively.* Two subfascial 15F silicone channel drains were placed; no suprafascial drains were used due to the limited space and adequate tension-free closure of the fascia and muscle. 3M™ Prevena™ Therapy was continued for 7 days postoperatively.

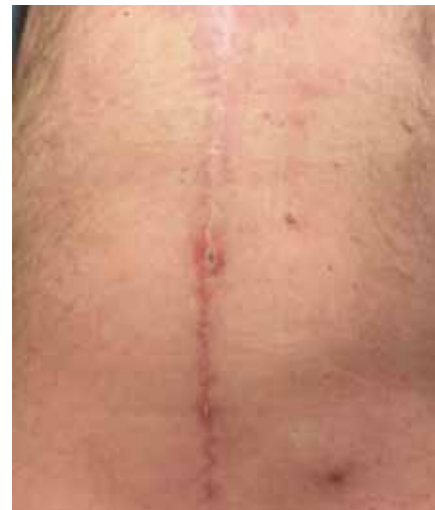
Figure 4. Incision healed six weeks after completion of 3M™ Prevena™ Therapy.

After conclusion of Prevena Therapy on postoperative day 7, the incision was cleaned with a chlorhexidine gluconate and isopropyl alcohol solution. The patient was discharged to acute rehab on postoperative day 9. Six weeks after completion of Prevena Therapy, the incision was completely healed with no complications (**Figure 4**).
