# Prevena Restor™

Postoperative Recovery

## Use of 3M™ Prevena Restor™ Adapti•Form™ Incision Management System after bilateral muscle advancement flap closure.

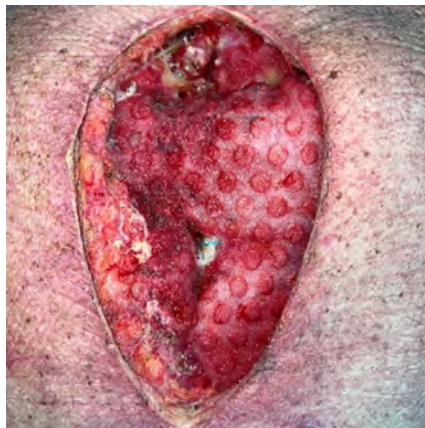
**Figure 1.** Open wound at presentation.

A 62-year-old male presented with delayed primary closure of skin flaps after excision of a sarcoma on the back (**Figure 1**). The patient's medical history included multiple myeloma and a diagnosis of plasmacytoma.

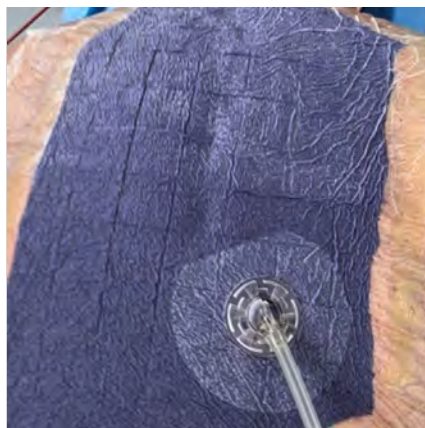
**Figure 3.** Application of the 3M™ Prevena Restor™ Adapti•Form™ Incision Management System over the closed incision in the operating room.

A 3M™ Prevena Restor™ Adapti•Form™ Dressing was applied over the surgical incision in the operating room.

The 3M™ Prevena Restor™ Therapy was initiated at -125 mmHg (**Figure 3**). A surgical drain was used independently of the Prevena Restor™ Adapti•Form™ Incision Management System and was routed under the skin beyond the boundary of the dressing.

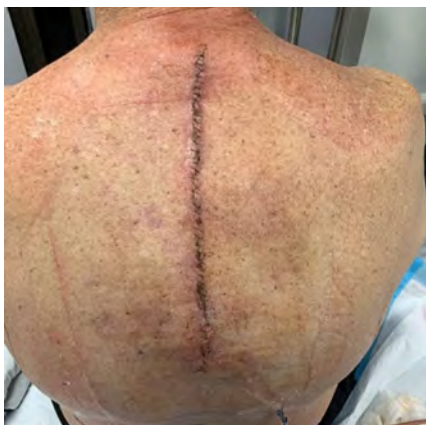
**Figure 4.** Dressing was removed on postoperative day 7.

The patient was discharged to home on postoperative day 3 and 3M™ Prevena Restor™ Adapti●Form™ Incision Management System was discontinued on postoperative day 7. The patient reported minimal to no discomfort while wearing the Prevena Restor™ Adapti●Form™ Dressing. When the dressing was removed, no edema was observed, the suture line appeared well-approximated, and there was minimal surgical drain output (**Figure 4**). No complications were reported during follow-up visits at postoperative days 14 and 30 (**Figures 5-6**).

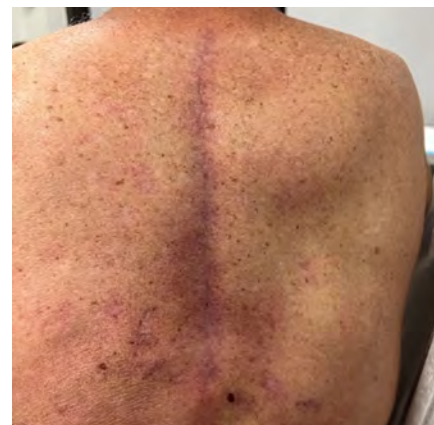
**Figure 5.** Follow-up on postoperative day 14

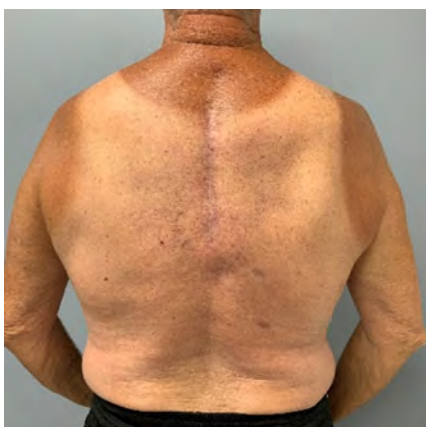
**Figure 6.** Follow-up on postoperative day 30.
