Management of double mastectomy with 3M[™] Prevena Restor[™] Bella●Form[™] Incision Management System

Allen Gabriel, MD, FACS; Global Surgical Consulting; Camas, WA

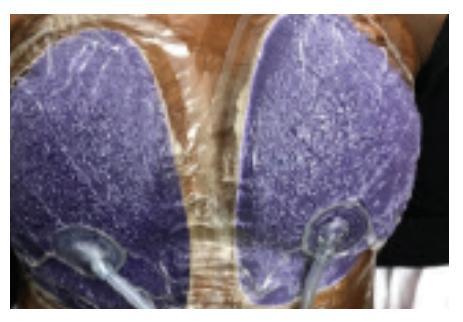
Figure 2. Application of 3M[™] Prevena Restor[™] Therapy with 3M[™] Prevena Restor[™] Bella●Form[™] Dressing post mastectomy.

3M[™] Prevena Restor[™] Therapy was initiated using 3M[™] Prevena Restor[™] Bella•Form[™] Dressing, which covered each inframammary incision and the entirety of each breast (**Figure 2**). Negative pressure was applied at -125mmHg continuously for 6 days.

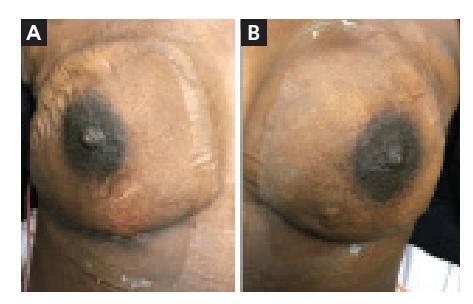
Figure 3. Appearance after 6 days of 3M[™] Prevena Restor[™] Therapy with 3M[™] Prevena Restor[™] Bella•Form[™] Dressing A. Right breast. B. Left breast.

The patient was discharged home the day after surgery. After 6 days, Prevena Restor Therapy was discontinued, and the incision remained closed (**Figure 3**). When the patient returned for follow-up on postoperative day 9, there were no complications and the drain was removed (**Figure 4**). At 30 days post-surgery, the incision remained closed, and there was no incidence of surgical site infection, seroma, or any other surgical complication.

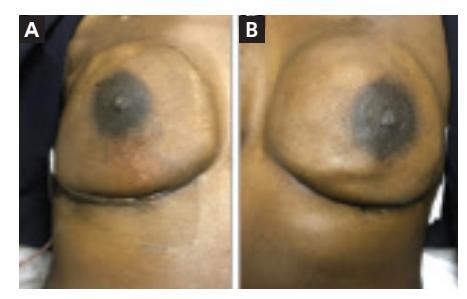
Figure 4. Appearance on postoperative day 9. **A.** Right breast. **B.** Left breast.
