Case series:
3M™ Kerramax Care™
Super-Absorbent Dressing for
the management of patients
with chronic wounds

CASE STUDIES SERIES 2024

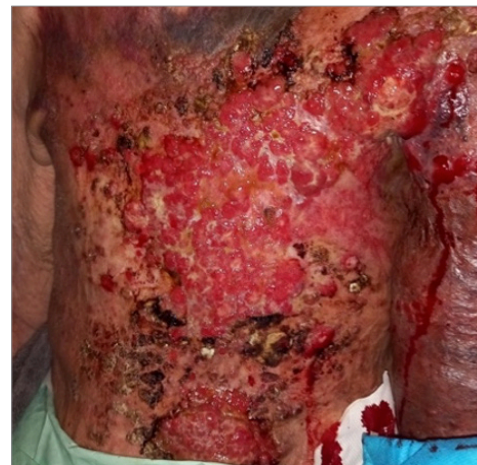
Figure 1. Extent of fungating wound at start of treatment with Kerramax Care Dressing

On presentation, the fungating wound was cancerous in nature and had been present for three months. It covered almost the entire front and side of the upper body and was composed of 100% unhealthy granulation tissue, which would result in frequent bleeding and dry scabs scattered throughout the wound [Figure 1]. The level of exudate was moderate with a thin, and watery consistency that would often soak through the dressing, causing leakage onto clothes and bed linen. The surrounding skin was extremely fragile and exhibited signs of inflammation, erythema and excoriation. The wound caused significant pain to the patient, who rated her pain as a 10 out of 10 (with 10 being the worst pain experienced). Consequently, the patient was prescribed morphine sulphate and other analgesics for pain management.

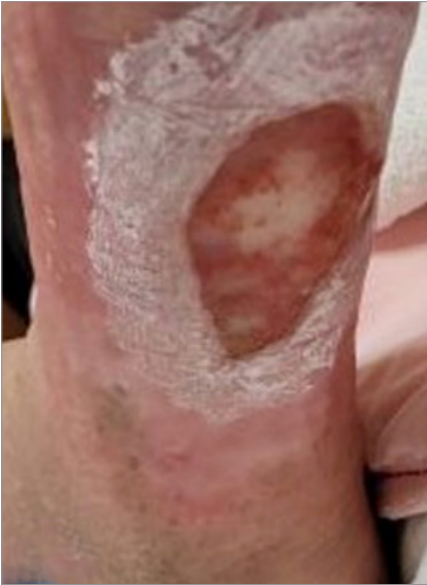
Figure 2. On presentation (Day 0), the ulcer was producing a high volume of fluid, and the wound bed was pale and contained fibrin

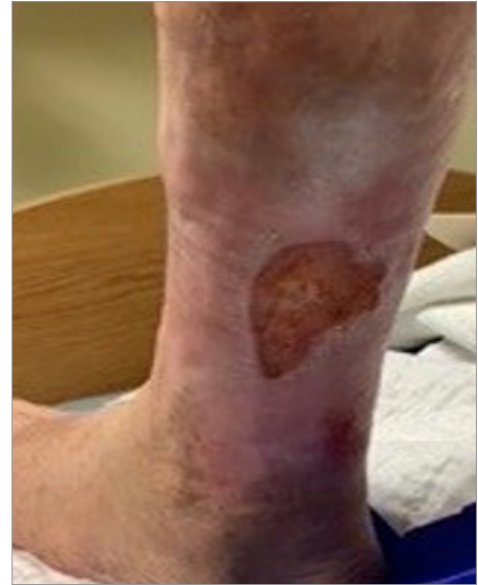
Figure 4. Following the use of Kerramax Care Dressing (Day 28) to manage exudate and Coban 2 Lite Compression System to manage oedema, the ulcer had significantly reduced in size and started to epithelialise

At her final review, the wound measured 5.4cm (length) x 4cm (width), the volume of exudate was low to moderate, and granulation was progressing well [Figure 4]. The patient's quality of life had improved: she reported no wound-associated pain and was very happy with the treatment, as the longer dressing wear time meant dressing changes could be planned.

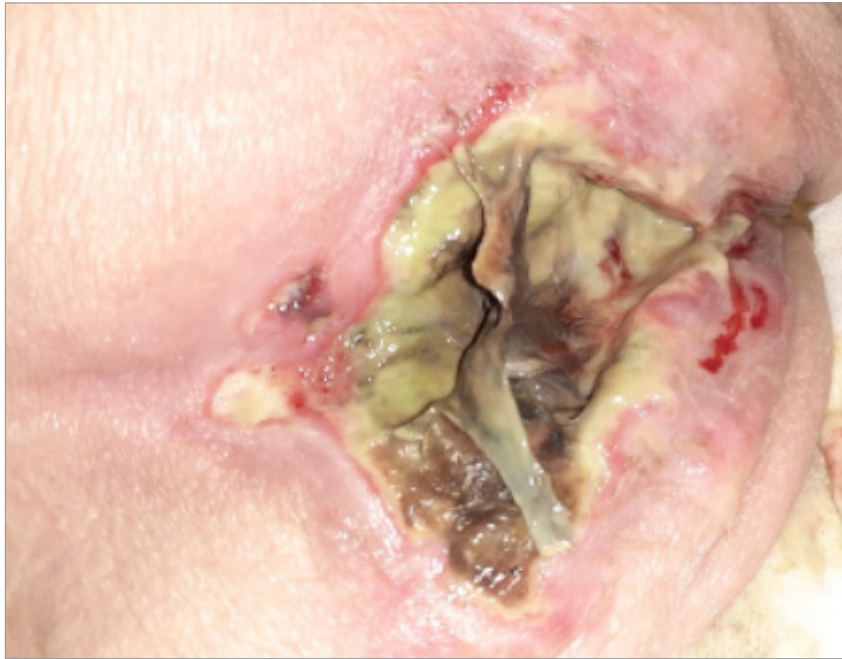
Figure 5. Sacral pressure ulcer on presentation and prior to start of treatment (Day 0)

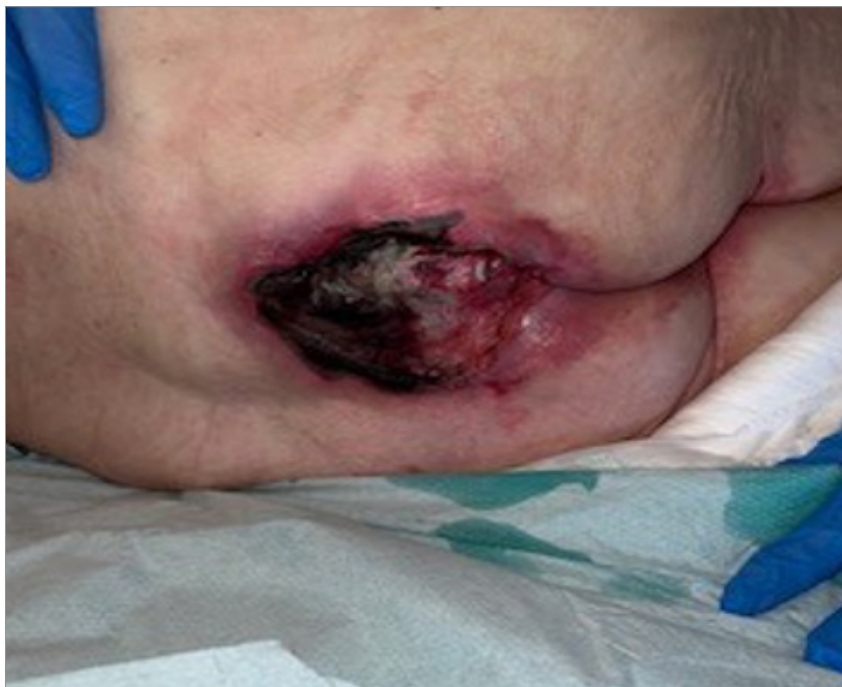
Figure 6. Sacral pressure ulcer following 14 days of treatment (including debridement and Kerramax Care Dressings)

Healing progression remained slow due to poor tissue perfusion [Figure 6], but as noted by her son, Kerramax Care Dressing continued to perform "exceptionally" well in terms of staying in place, exudate management, and improvement of skin integrity.

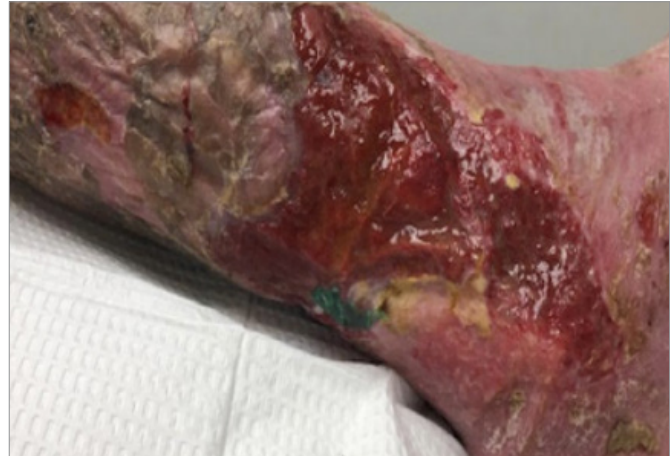
Figure 8. On day 0, the ulcers were extensive, covering the calf and ankle, while the surrounding skin was discoloured and friable

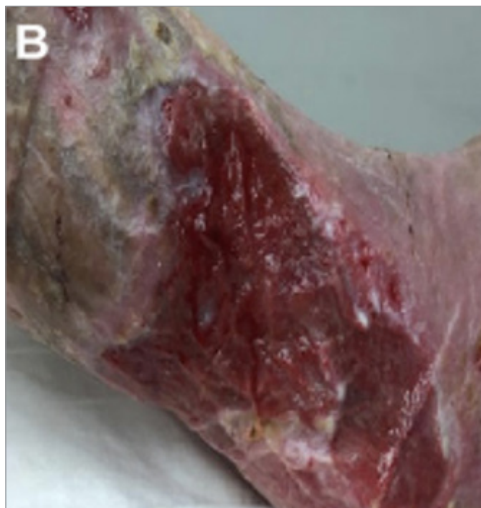
Figure 9. (a) On Day 7, Kerramax Care Dressing had absorbed and retained the lymphatic fluid, (b) protecting the wound bed and surrounding skin, which had improved

The wound bed was a healthier colour and no longer wet, while the periwound skin was less erythematous and cracked [Figure 9b]. Oedema of the lower limb had decreased as a result of consistent compression. Treatment was continued with weekly planned dressing changes.

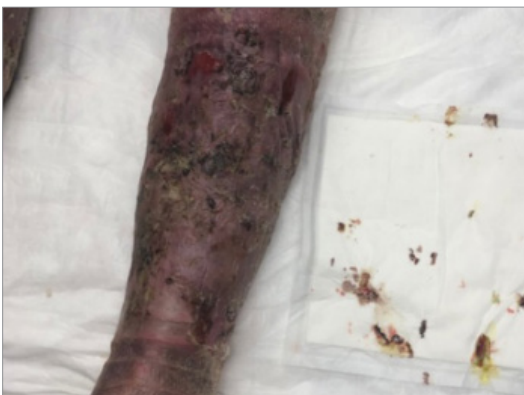
Figure 10. On Day 28, the ulcers had healed and oedema had significantly decreased

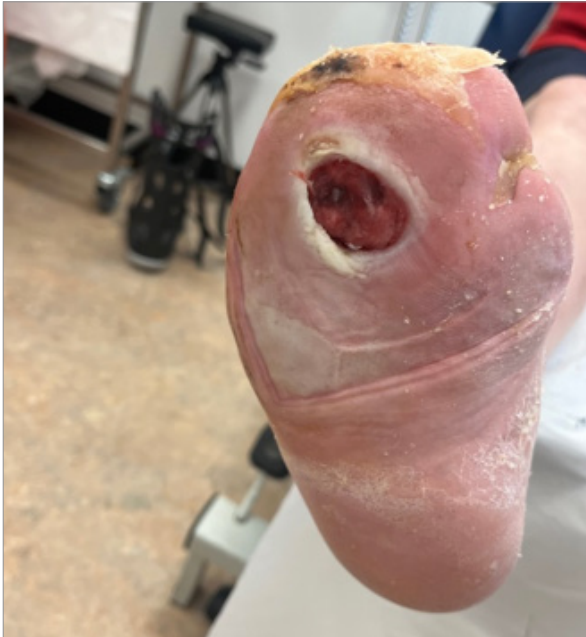
Figure 11. Diabetic foot ulcer on plantar surface of the right foot at presentation (Day 1)

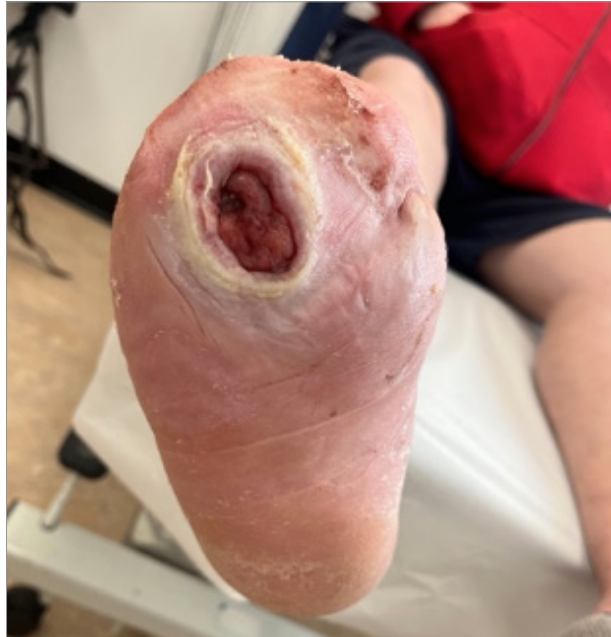
Figure 12. Diabetic foot ulcer on plantar surface of the right foot after 21 days of treatment

At the fourth dressing review, seven days later, the wound appeared visibly smaller in size and measured 2.5cm (length) x 3.7cm (width) x 0.2cm (depth) [Figure 12]. There was less maceration around the wound margins, and the surrounding skin was in good condition.

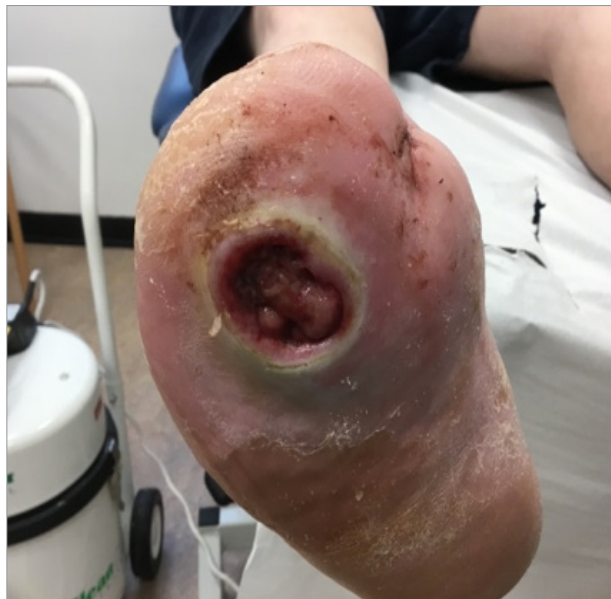
Figure 14. After 44 days of treatment. Note, ulcer is slightly larger in size due to deteriorating systemic health of the patient

Following the fourth dressing review, it is noted that the wound had become slightly larger in size due to deteriorating underlying cardiac problems and poorly controlled diabetes which impacted on healing progression [Figure 13 and 14 for wound on Day 29 and 44 of treatment, respectively].

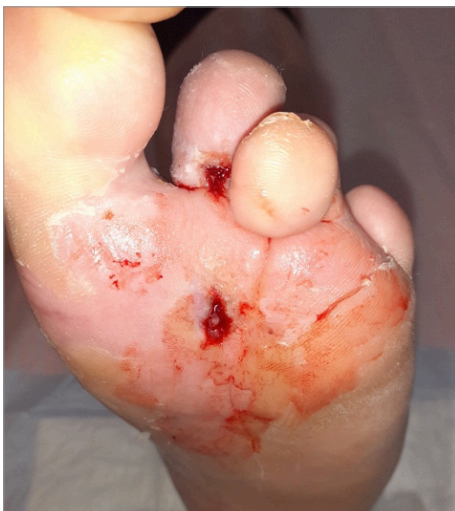
Figure 17. Diabetic foot ulcer and fistula to the second toe following 23 days of treatment with Kerramax Care Dressings

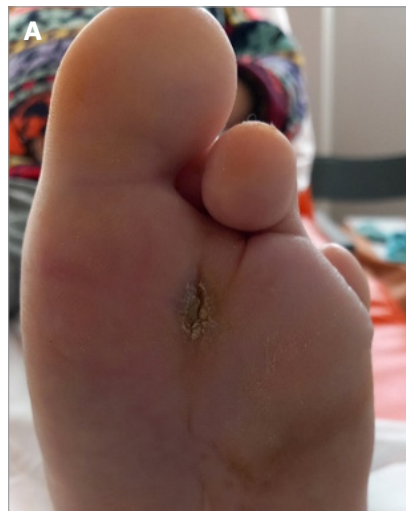
Figure 18. Diabetic foot ulcer at follow-up appointment on day 46, (a) before debridement and (b) after debridement

At the follow-up appointment, the wound's depth had completely resolved and now measured 0.1cm (length) x 0.1cm (width), consisting entirely of granulation tissue. Initially, slight hyperkeratosis was observed [Figure 18a], but after minimal debridement, it was no longer present, resulting in healthy-looking surrounding skin [Figure 18b].
